ARIZONA DEPARTMENT OF TRANSPORTATION

REPORT NUMBER: FHWA-AZ-8604

CRACK AND SEAT CONCRETE PAVEMENT

Construction Report

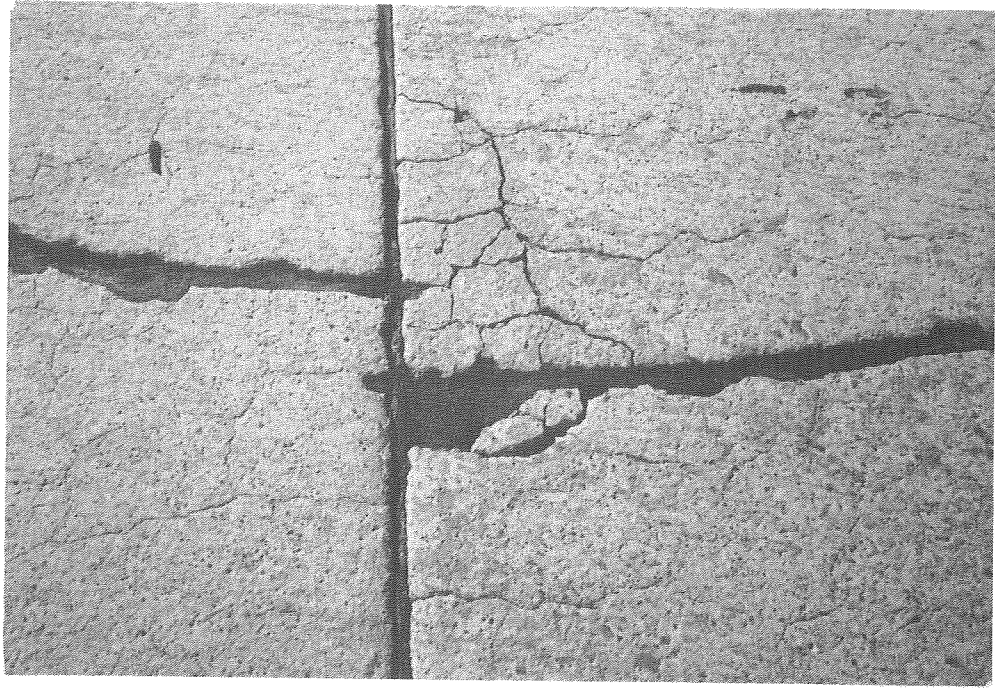
Spalls were frequently seen throughout the project and some cracks were found to be as wide as 1". Although the joints were sealed, the sealant was loose and had separated from the joints. Many of the broken slabs had not been sealed. The slabs which were sealed, however, appeared to have been oversealed. This is visible in Figures 1 and 2. Aside from the cracks and the faults, the concrete pavement had only a few areas patched with asphalt concrete.

Figure 1. Typical Severe Cracking of the PCCP Near Joints

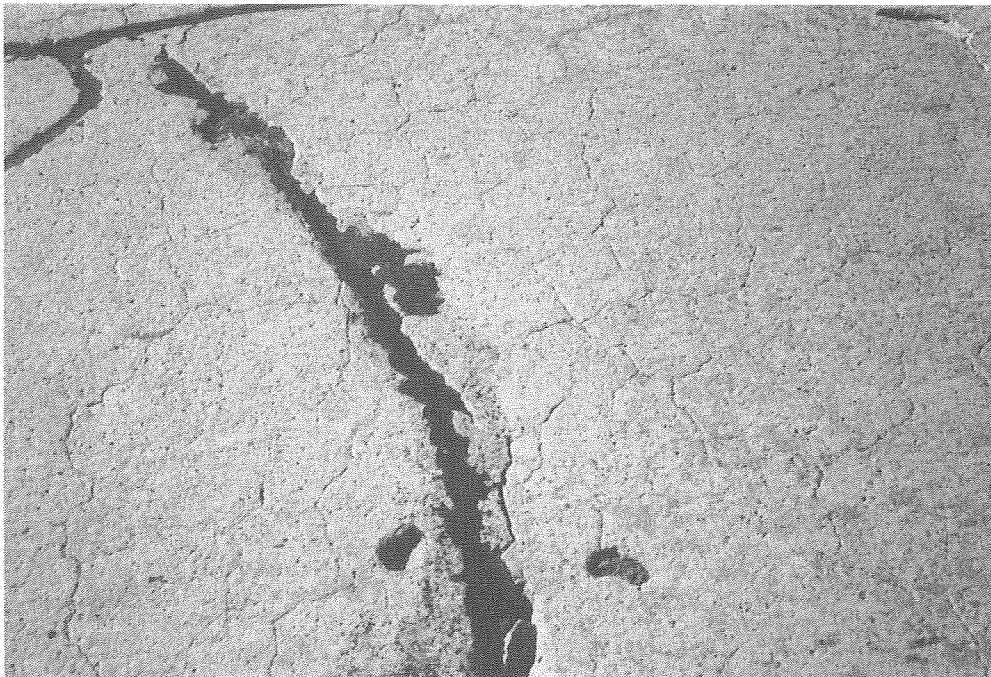
Figure 2 Typical Block Cracking of the PCCP

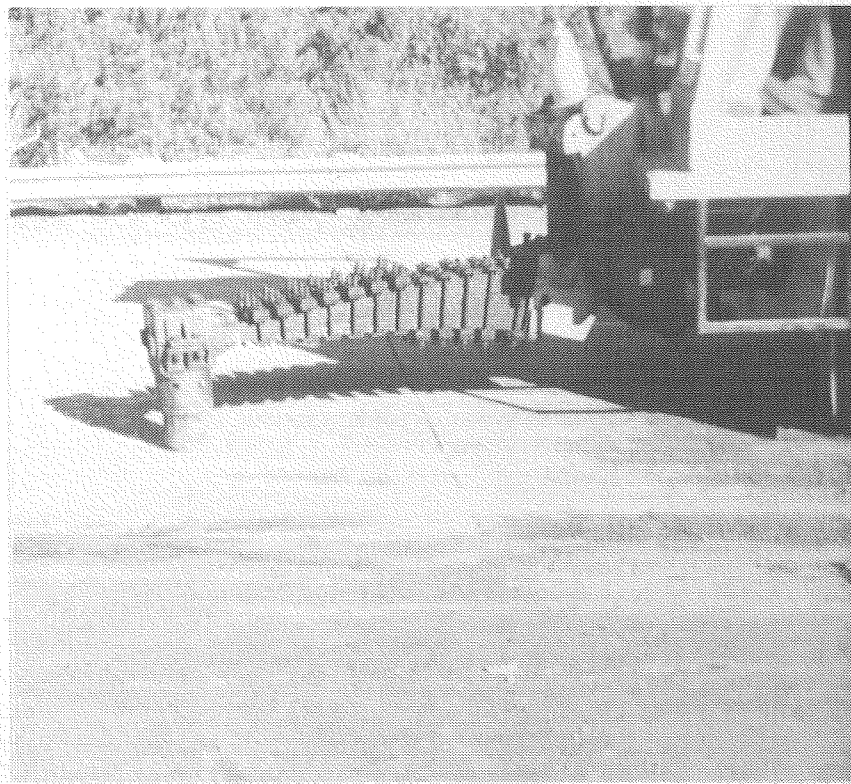
The cracking of the PCCP was accomplished using a whiphammer (Figure 3). The whiphammer utilized a centrally mounted impact device which was thrown against the pavement with a whip-like action impacting the pavement with a rectangular foot print (typical dimensions of approximately 4.5" x 7.0"). The special provisions specified cracking patterns of 3' x 3', 4' x 6' and 2' x 2' (See Appendix B for a copy of the special provisions).

Figure 3 The Whiphammer Used for Cracking the PCCP

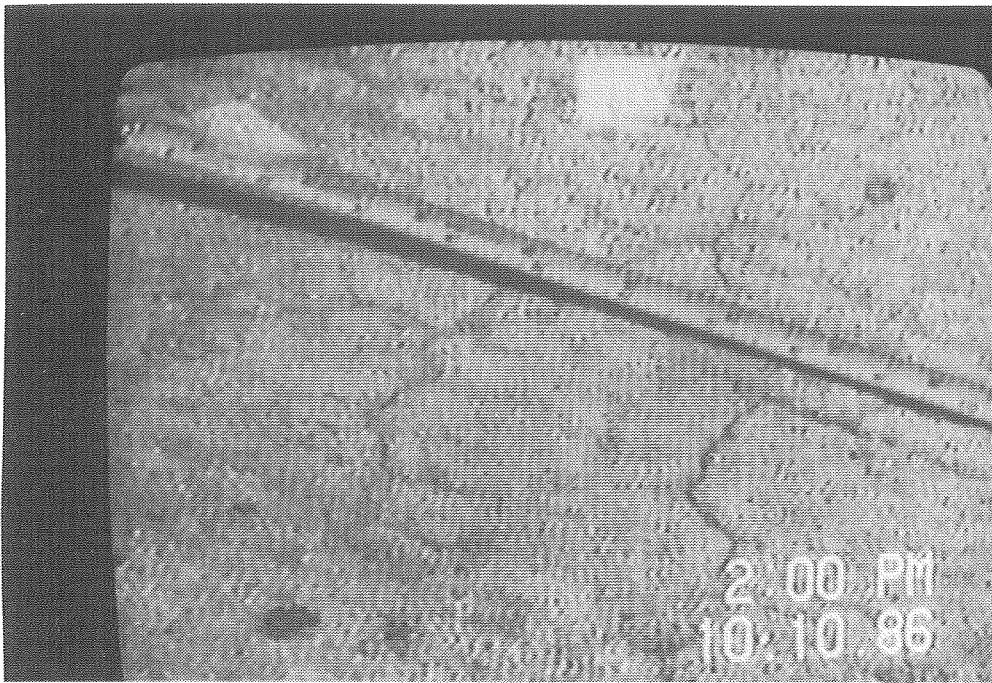
Figure 4 Typical Cracking Pattern of the Whiphammer

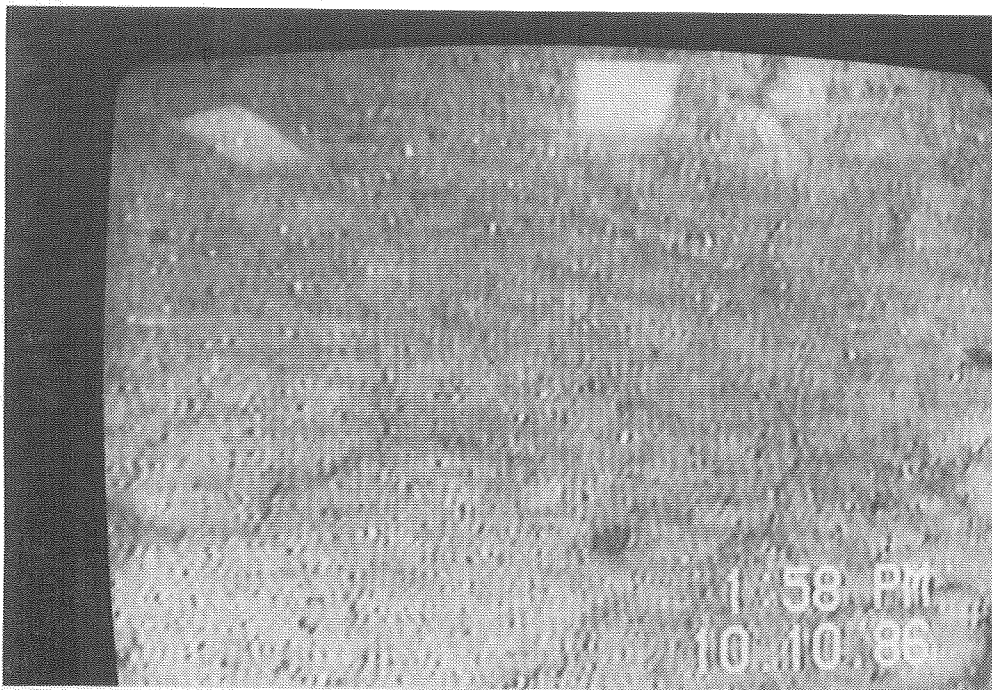
Figure 5 Typical Cracking Pattern of the Whiphammer

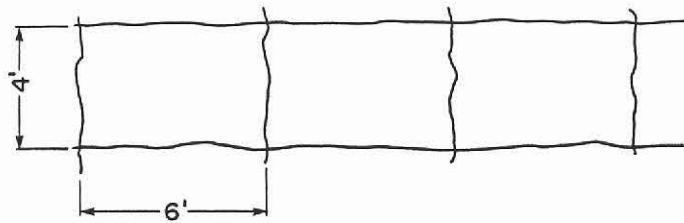
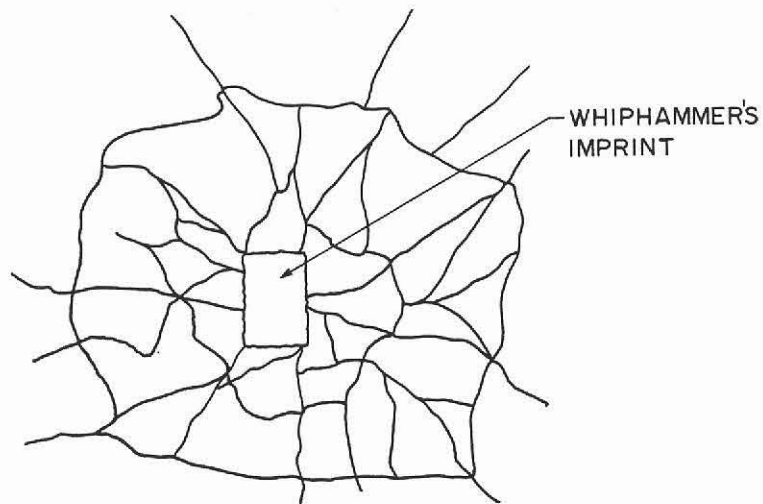
Figure 6 Rendering of the Expected and the Produced Cracking Pattern

TYPICAL "SPIDER WEB" CRACKING PATTERN
PRODUCED BY THE WHIPHAMMER

The size of the cracked pieces ranged between four and nine square feet. The cracked pieces were generally not square but were usually diamond or triangular in shape. A "Spider web" type of cracking pattern was produced by the Whiphammer. The cracks were not visually detectable on a dry pavement; therefore the pattern was checked periodically by applying water to the cracked surface so that the cracks could be more readily detected. Figures numbered 4 and 5 show a typical cracked PCCP. Figure 6 shows a rendering of the expected and the produced cracking pattern. Cores, randomly taken, verified that the hairline cracks penetrated the full depth of the slab (Figure 7).

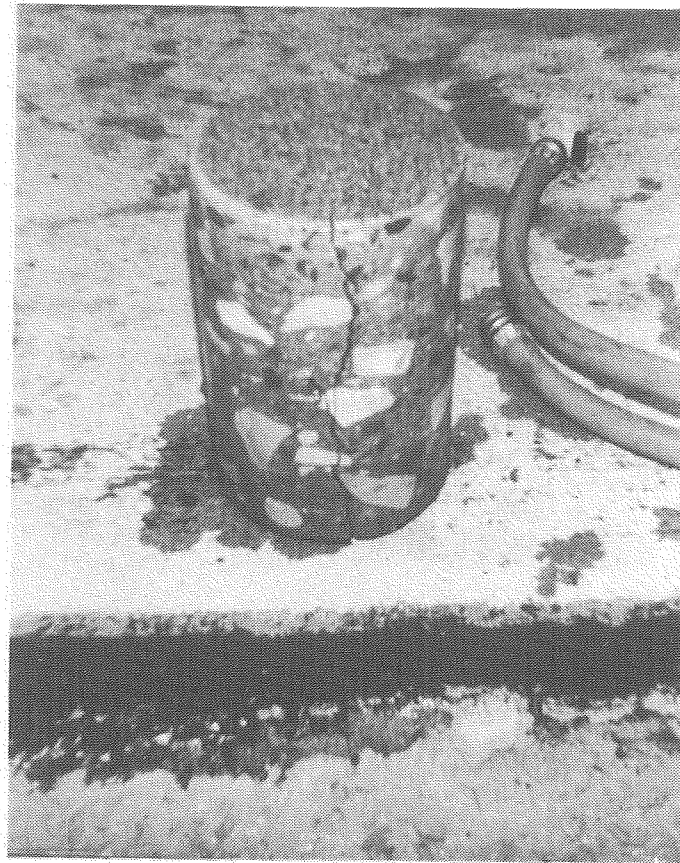
Figure 7 Core Thru the Cracked PCCP

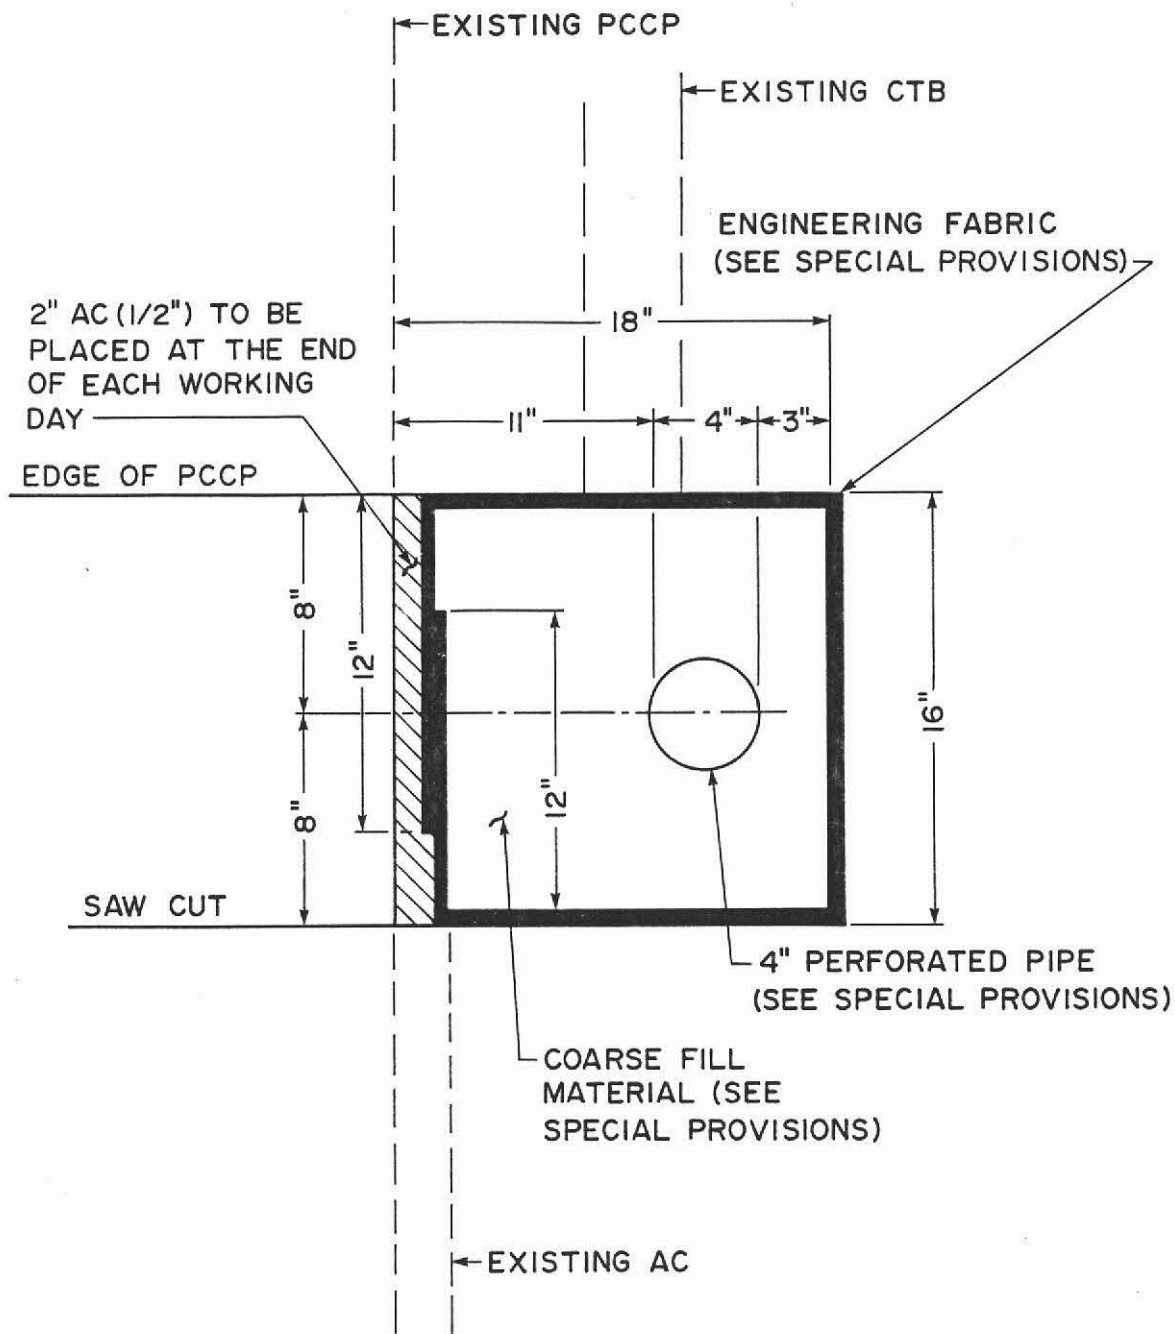
Figure 8 Collector Trench Drainage Design

The quality of the subsurface materials is highly suspect in the same areas that the slabs in the PCCP were in very poor condition. Since many of the broken slabs had not been sealed, water was allowed to intrude into the base materials. To ensure proper drainage, a collector trench was constructed on the edge of the PCCP (Figure 8 shows a typical section of the collector trench). The installation of the subsurface drainage collector system exposed approximately nine inches of the base material and it was observed that free water was frequently present at less than nine inches below the bottom of the slabs.

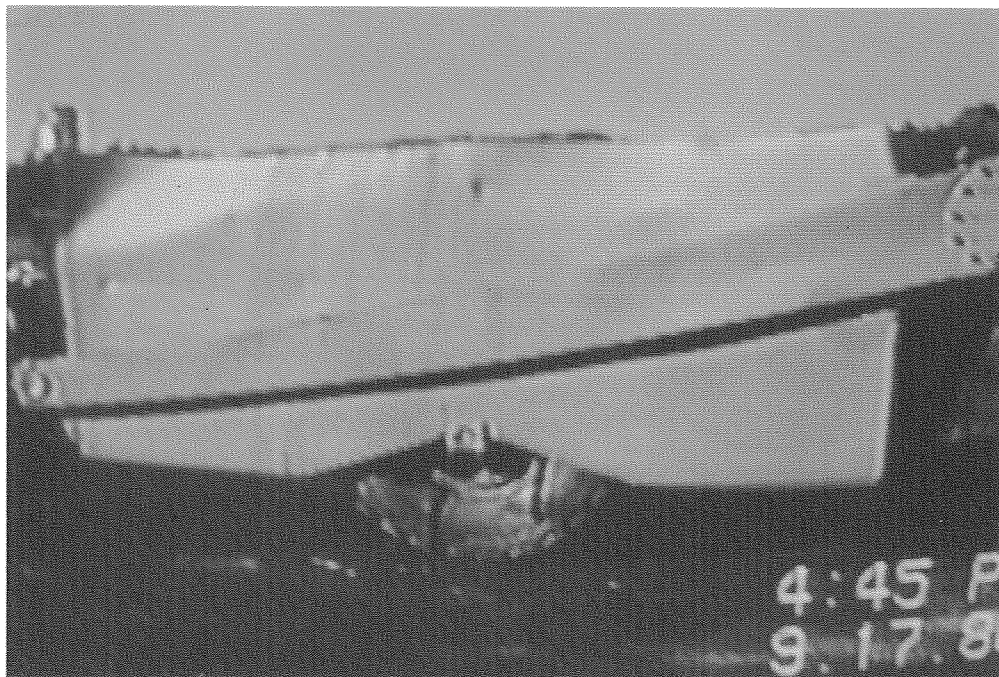
The seating of the cracked PCCP slabs was conducted by rolling the slabs with at least 2 passes of a 50 ton "wagon-like" tire roller filled with sand ballast (Figure 9). Traffic was not allowed on the cracked and seated pavement for about 72 hours, and in general, the bottom 2 inch lift of the HMAC overlay was laid within 72 hours after the crack and seat operations, as per the special provisions.

Figure 9 Tire-Roller Used for Seating the Cracked PCCP
